COOLING TOWER FAN BLADE REFURBISHMENTS

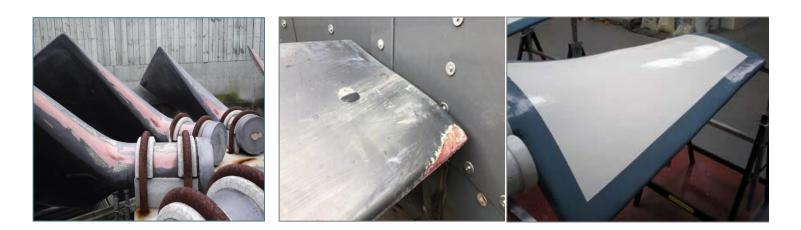
Erosion on the leading edges, cracks and flaking on trailing edges of the cooling tower fan blades caused by UV degradation, erosion and impingement. This reduces the overall efficiency and operation of the cooling system. The refurbishment has avoided the high cost of blade replacement. The work was carried out within the fan cell, again reduced time and removal costs

The application was carried out by our in-house laminators in accordance with fan manufacturers repair procedures. The leading and trailing edges were rebuilt with FRP materials and coated with a high-grade polyester top gel coat to protect the repair.
